# HANNA WASH AUSTRALIA CAR WASH PROCESS VALIDATION

March 2011

**Client:** Hanna Wash Australia  
**Project Title:**  
**Report Title:** Car Wash Process Validation  
**Document No:** 1054-2011-016  
**Document Status:** Final  
**Date of Issue:** March 2011  
**Comments:** Final

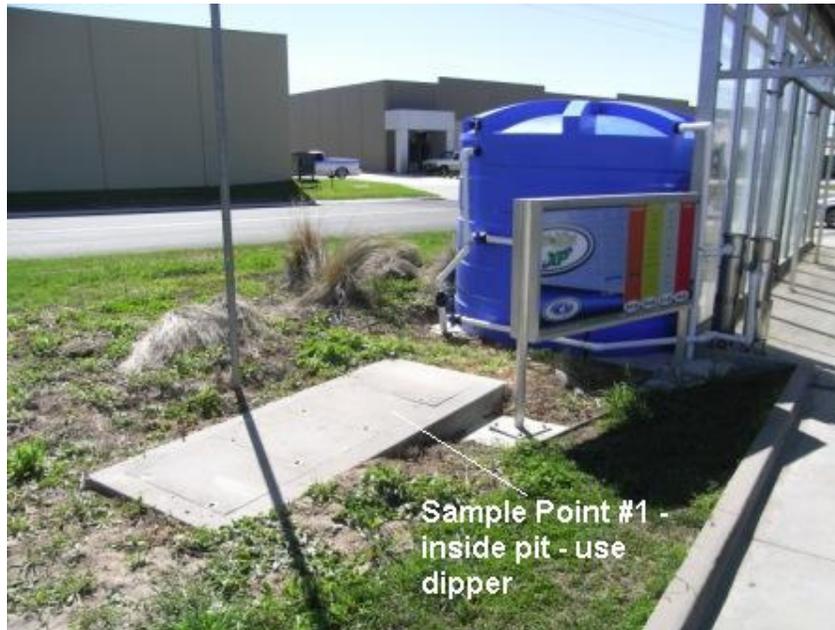
**Figure 2-1: Location of sample point #1 (source water) - Tank #1**

- The wash bay pit is not recommended as a sampling point within the ACWA guidelines (Table 7) because it is thought to be difficult to get a homogenous sample from the pit.
- Tank #1 is the first contact point for the source water into the continuous recycling loop and provided a representation (although a diluted one) as to the source water quality, especially soon after a car was washed (which was the case during sampling runs).

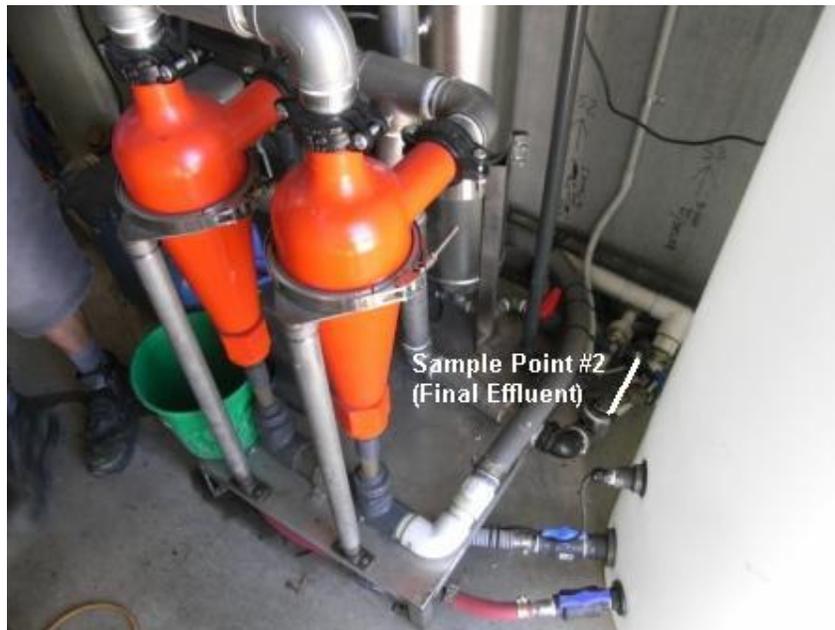
**Figure 2-2: Location of sample point #2 (final effluent) - inside control room**
